FULL RESERVE STUDY

Hayden Falls Condominium Association #1

Dublin, Ohio
March 21, 2017

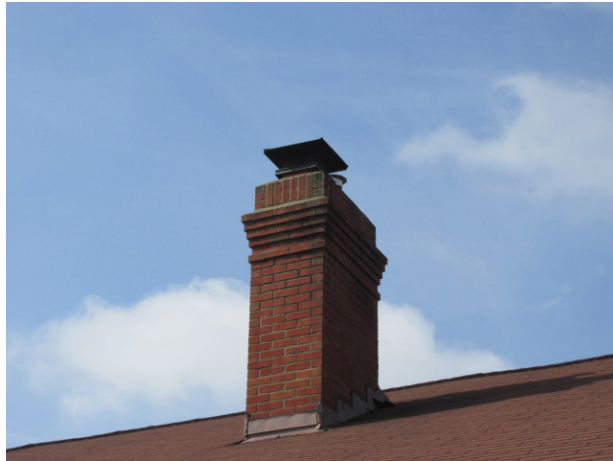
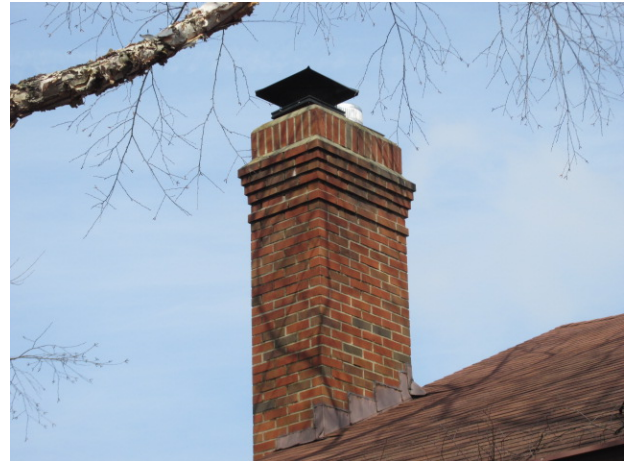
Condition: Fair overall based on our visual inspection from the ground

Masonry chimney

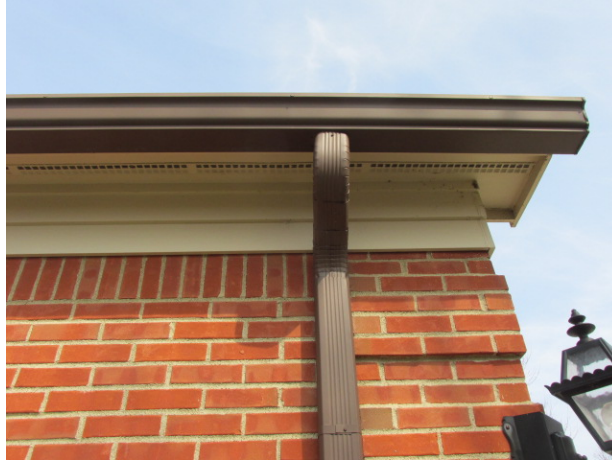
Condition: Good to fair overall

Gutter and downspout configuration

Component Detail Notes: Downspouts that discharge directly onto roofs cause premature deterioration of the roofs due to the high concentration of storm water. We recommend either routing these downspouts directly to the ground, connecting the downspouts to the gutters of the lower roof or distributing the storm water discharge over a large area.

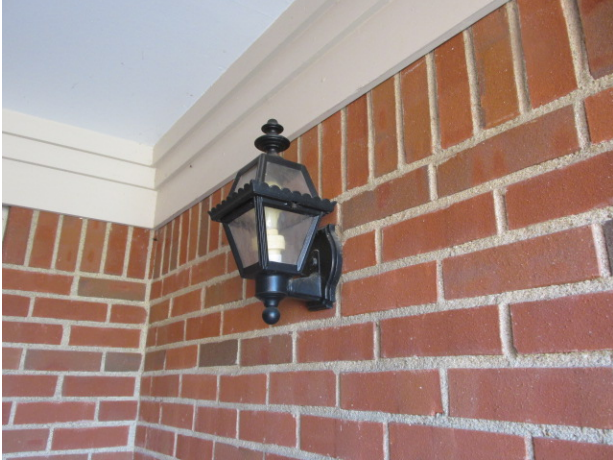
Condition: Good to fair overall condition

Front entrance light fixture

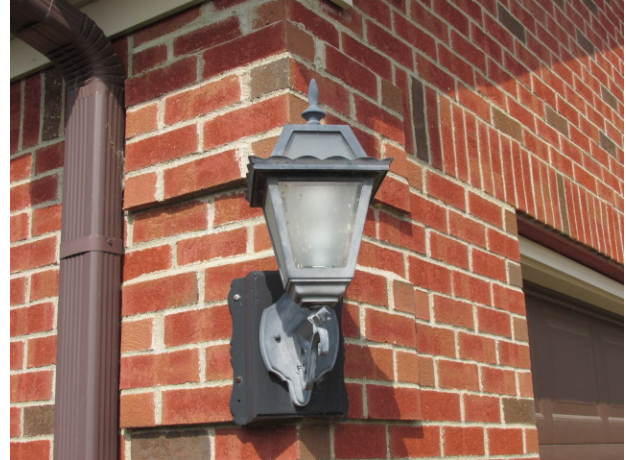
Garage light fixture

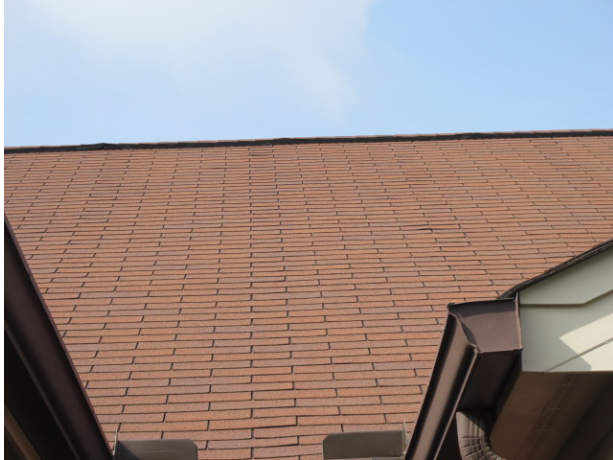
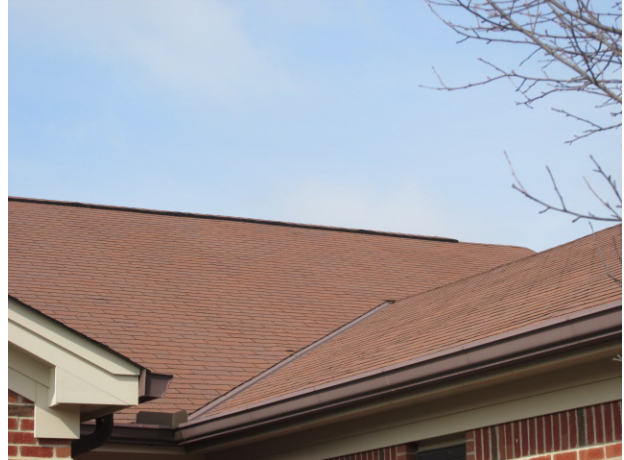
Condition: Good to fair overall condition. We note areas of loose, missing and curling shingles

Shingle lift at 2003-2005 Buildings

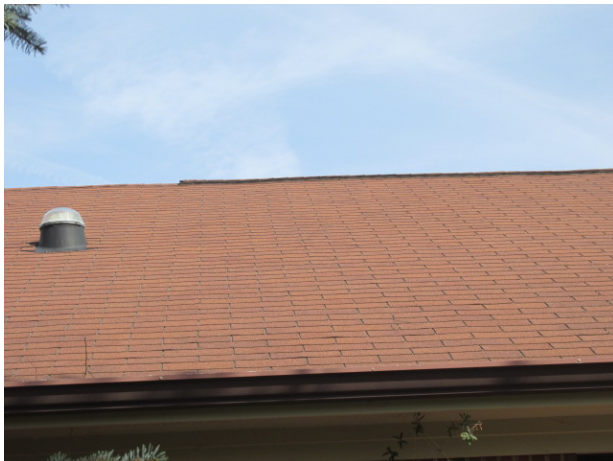
Asphalt shingle roof

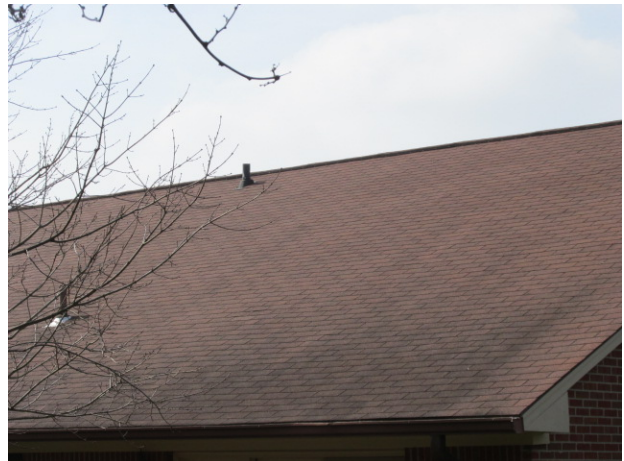
Discoloration at asphalt shingle roof

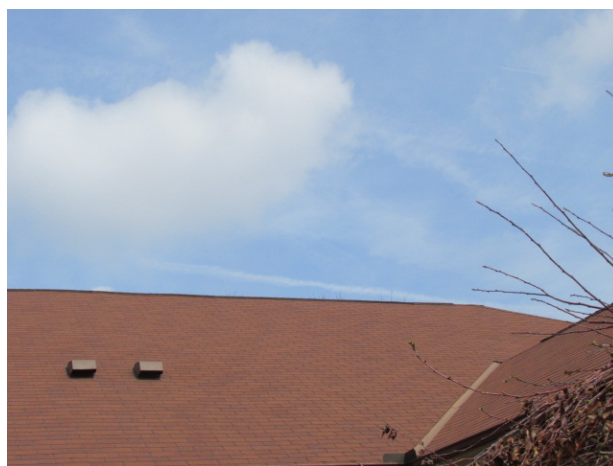
Asphalt shingle roof

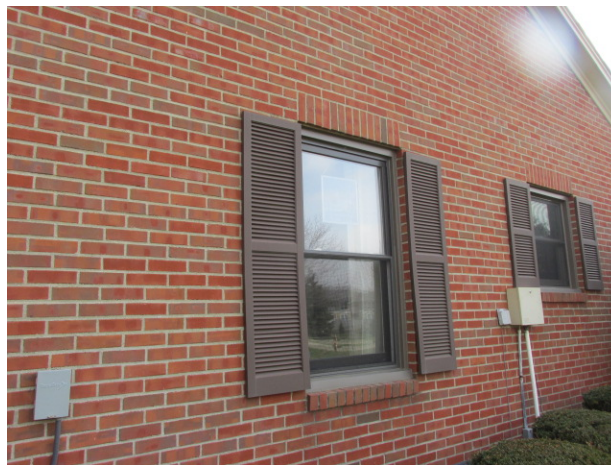
Condition: Good to fair overall

Shutters

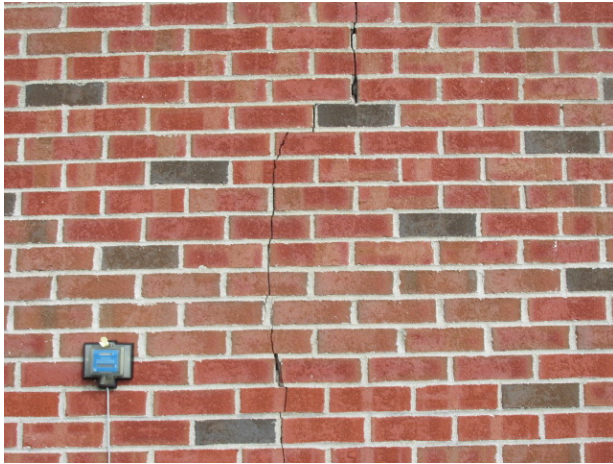
History: Original. The Board informs us that the Association conducts annual repairs to the masonry at the building exteriors. However, we note multiple areas of large

cracks in need of repair and recommend the Association fund future repairs to the masonry through Reserves.

- Minimal previous repairs evident
- Efflorescence is not visible
- Lintel paint finish in good condition
- Masonry exhibits cracks
- No spalled masonry is evident
- Mortar deterioration is evident

Large masonry crack at Unit 5715

- Complete inspection of the masonry
- Repointing of up to two percent (2%) of the masonry
- Replacement of a limited amount of the masonry
- Paint applications to the metal lintels (approximately 4,540 linear feet)
- Replacement of up to twenty-five percent (25%) of the sealants at the window and door perimeters

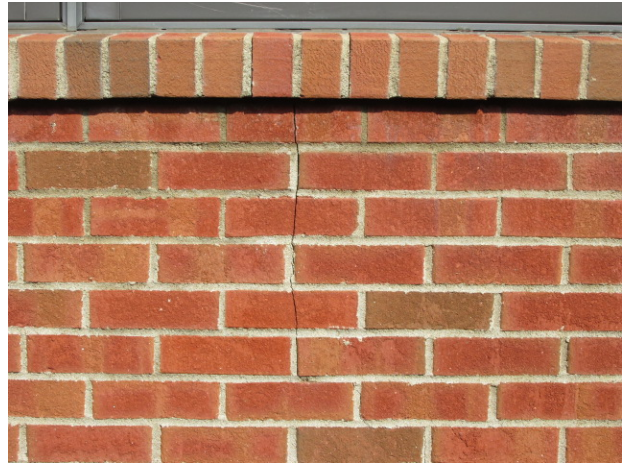
Crack at masonry

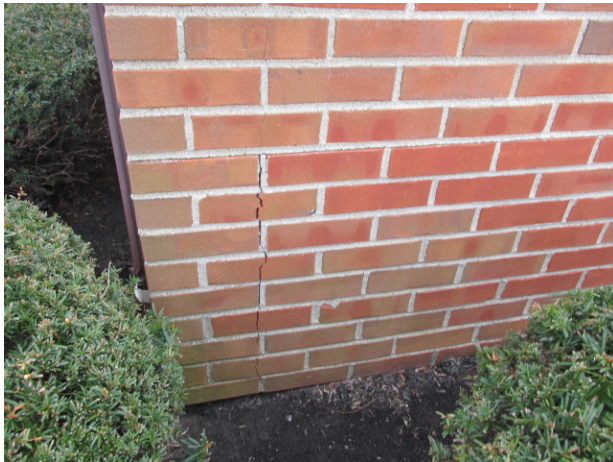
Crack at masonry

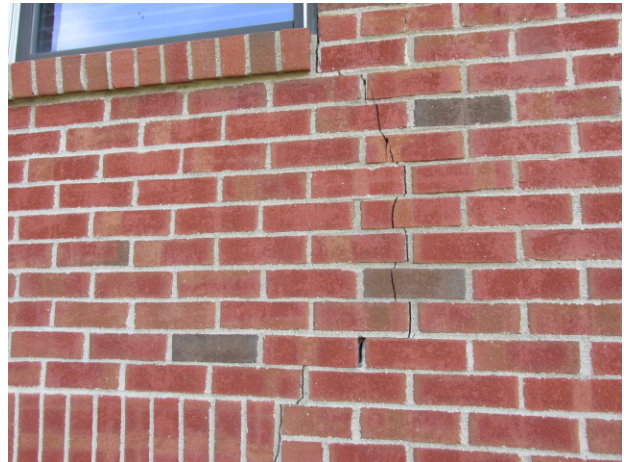
Step crack at masonry

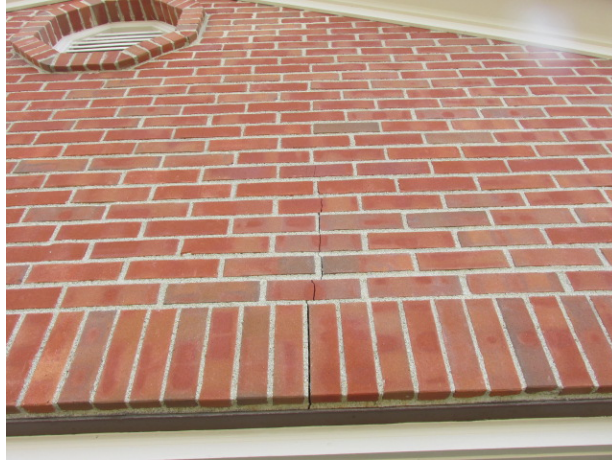
Crack at masonry above garage

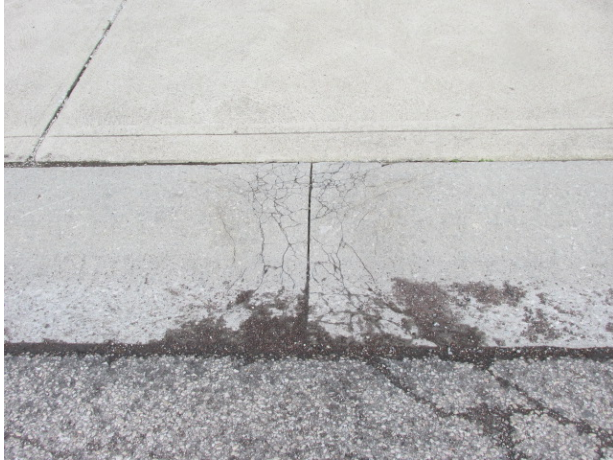
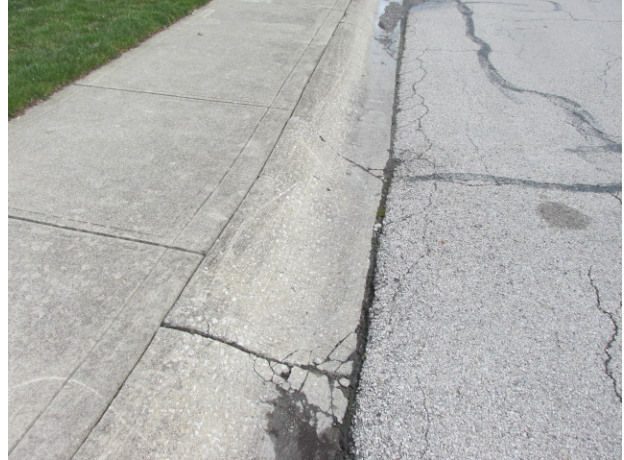
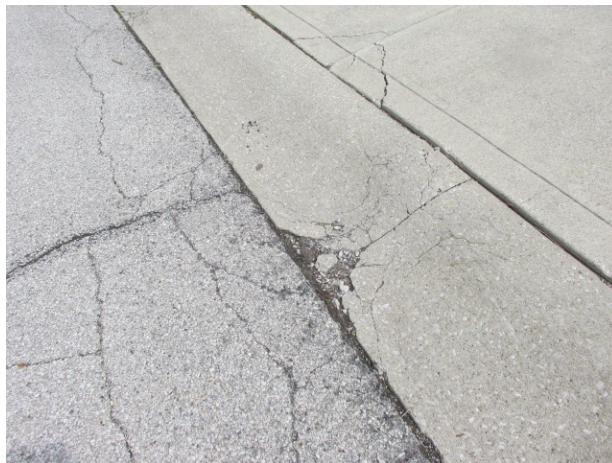
Condition: Good to fair overall with crack and deterioration evident

Cracks and deterioration at curb and gutter

Expenditure Detail Notes: Expenditure timing and costs are depicted in the **Reserve Expenditures** table in Section 3. We estimate that up to 1,000 linear feet of curbs and gutters, or twenty percent (20%) of the total, will require replacement during the next 30 years.

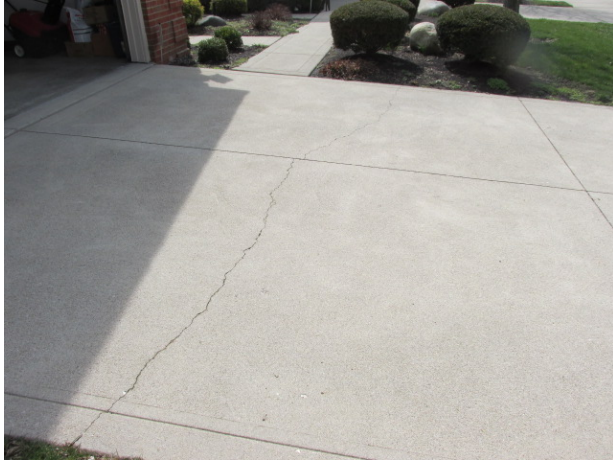
Condition: Fair to poor overall condition. We note areas of large cracks and deterioration.

Crack at driveway

Expenditure Detail Notes: Expenditure timing and costs are depicted in the **Reserve Expenditures** table in Section 3. We estimate that up to 23,650 square feet of concrete driveways, or thirty percent (30%) of the total, will require replacement during the next 30 years.

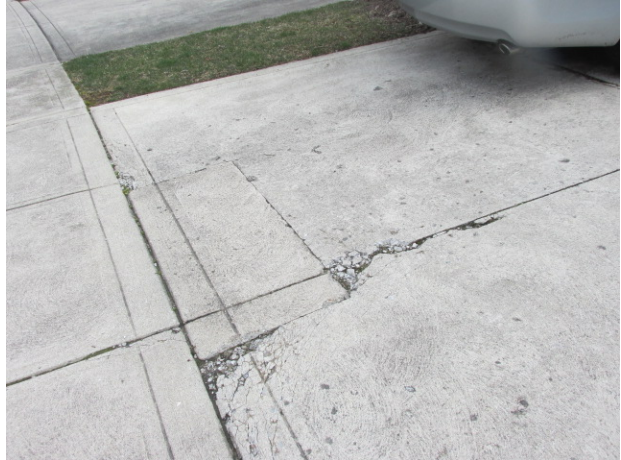
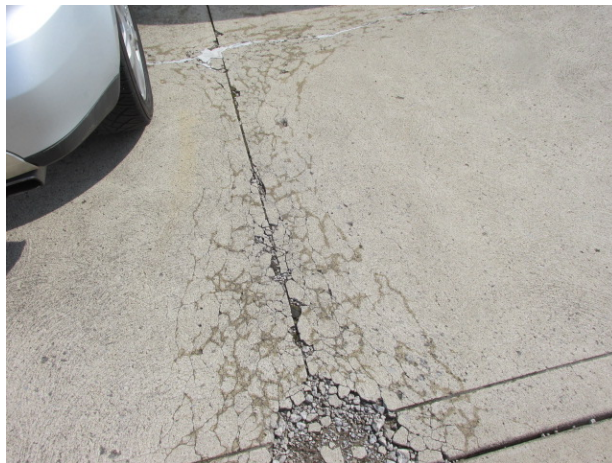
Cracks and deterioration at driveway

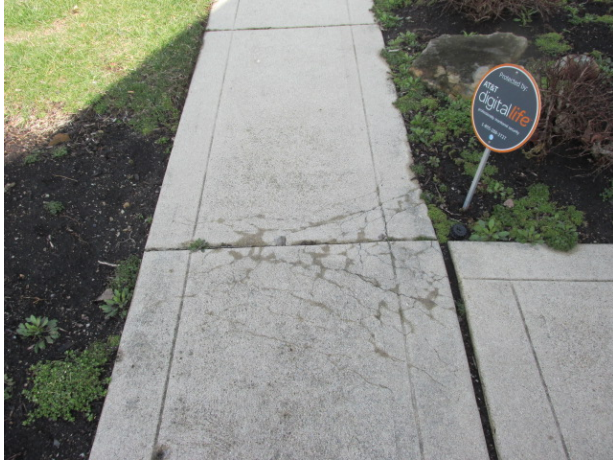
Condition: Good to fair overall with cracks and deterioration evident

Cracks at sidewalk

Expenditure Detail Notes: Expenditure timing and costs are depicted in the **Reserve Expenditures** table in Section 3. We estimate that up to 9,150 square feet of concrete sidewalks, or forty percent (40%) of the total, will require replacement during the next 30 years.

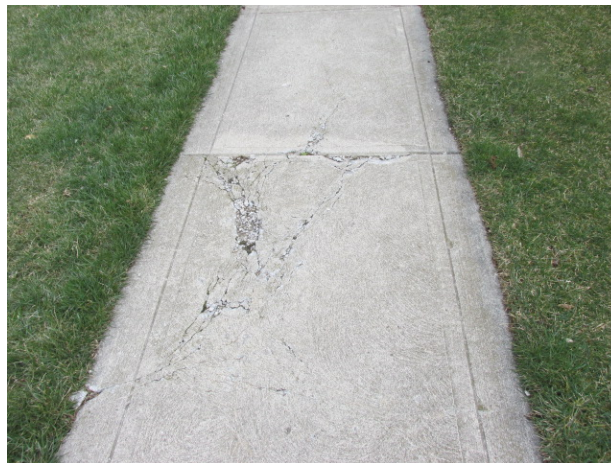
Cracks at deterioration at concrete sidewalk

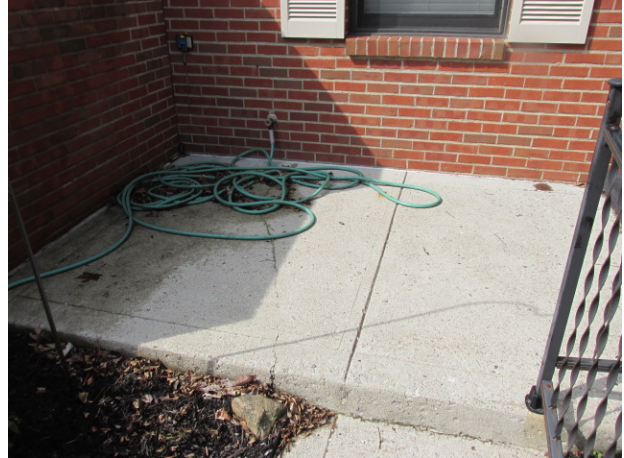
Condition: Good to fair overall with isolated crack evident

Crack at concrete stoop

Expenditure Detail Notes: Expenditure timing and costs are depicted in the **Reserve Expenditures** table in Section 3. We recommend the Association plan for replacement of up to 50 stoops, or approximately fifty-two percent (52.1%) of the total, during the next 30 years.

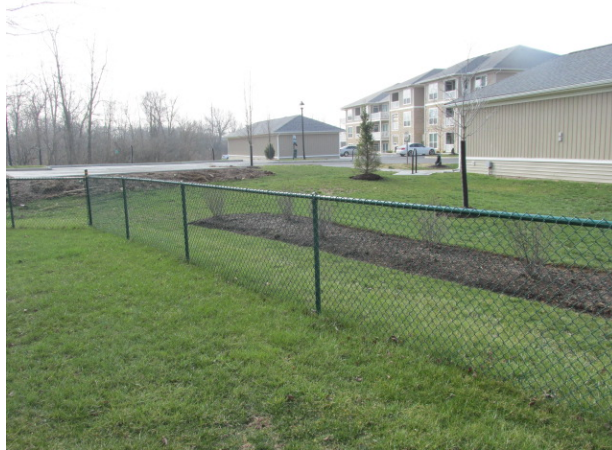
Condition: Good overall with no visible deterioration evident

Chain link fence

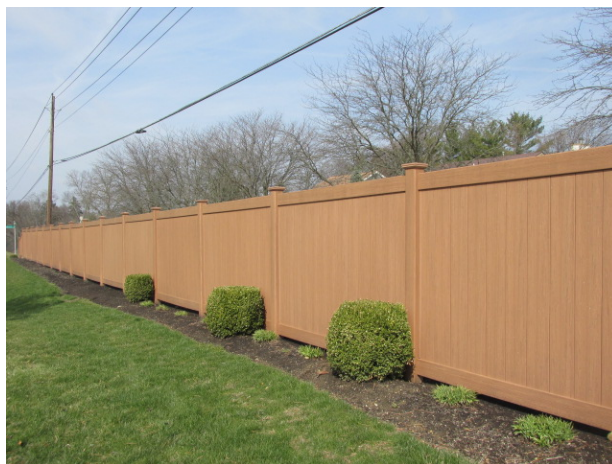
Condition: Good overall condition

Composite fence

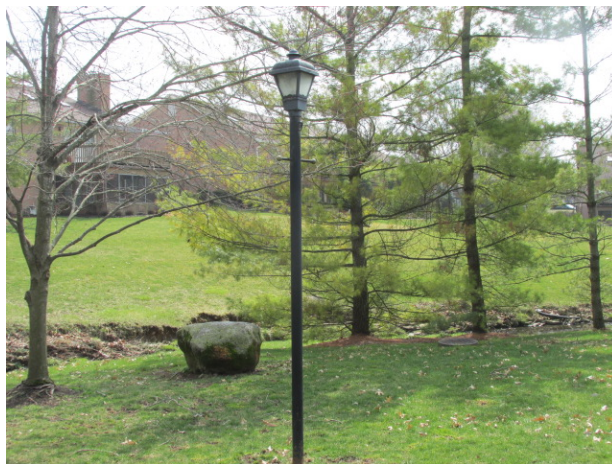
Condition: Good to fair overall

Light pole and fixture

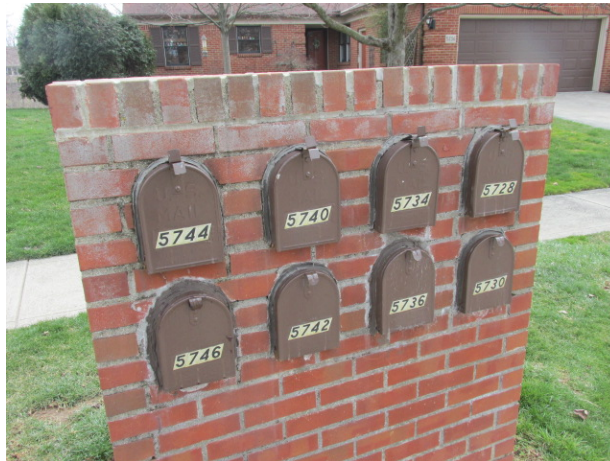
Condition: Fair to poor

Mailboxes

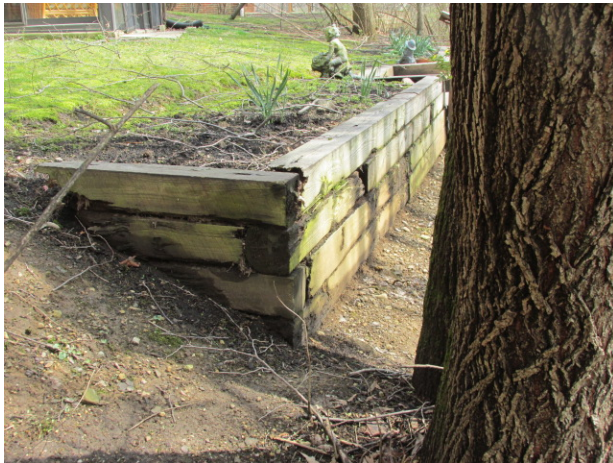
Condition: Fair overall with wood deterioration evident

Wood deterioration

Component Detail Notes: We advise Hayden Falls replace with a modular, interlocking dry-set masonry retaining wall system. The cost of dry-set masonry retaining walls is similar to the cost of timber walls. However, dry-set masonry retaining walls offer a longer useful life of up to 35 years and lower total maintenance costs.

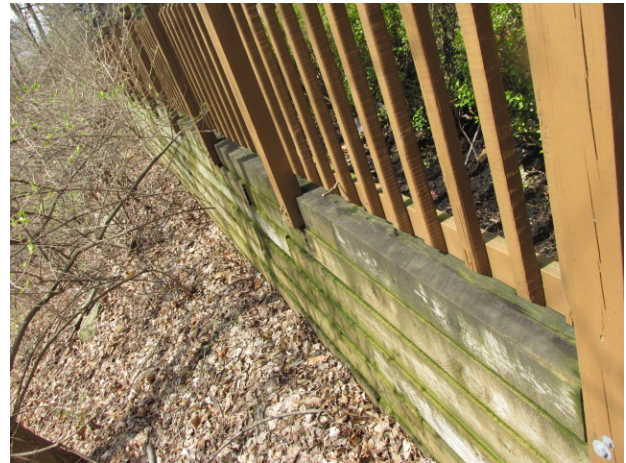
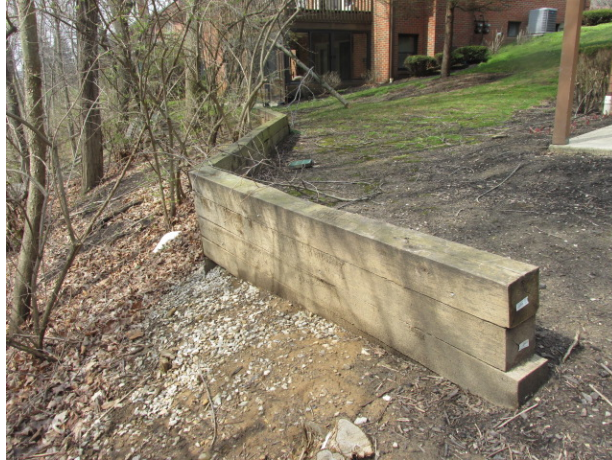
Timber retaining wall
